National Instrument 43-101 Technical Report : Geology and Exploration Review at the Gold Basin Project Mohave County, Arizona USA

CanEx Metals Inc.

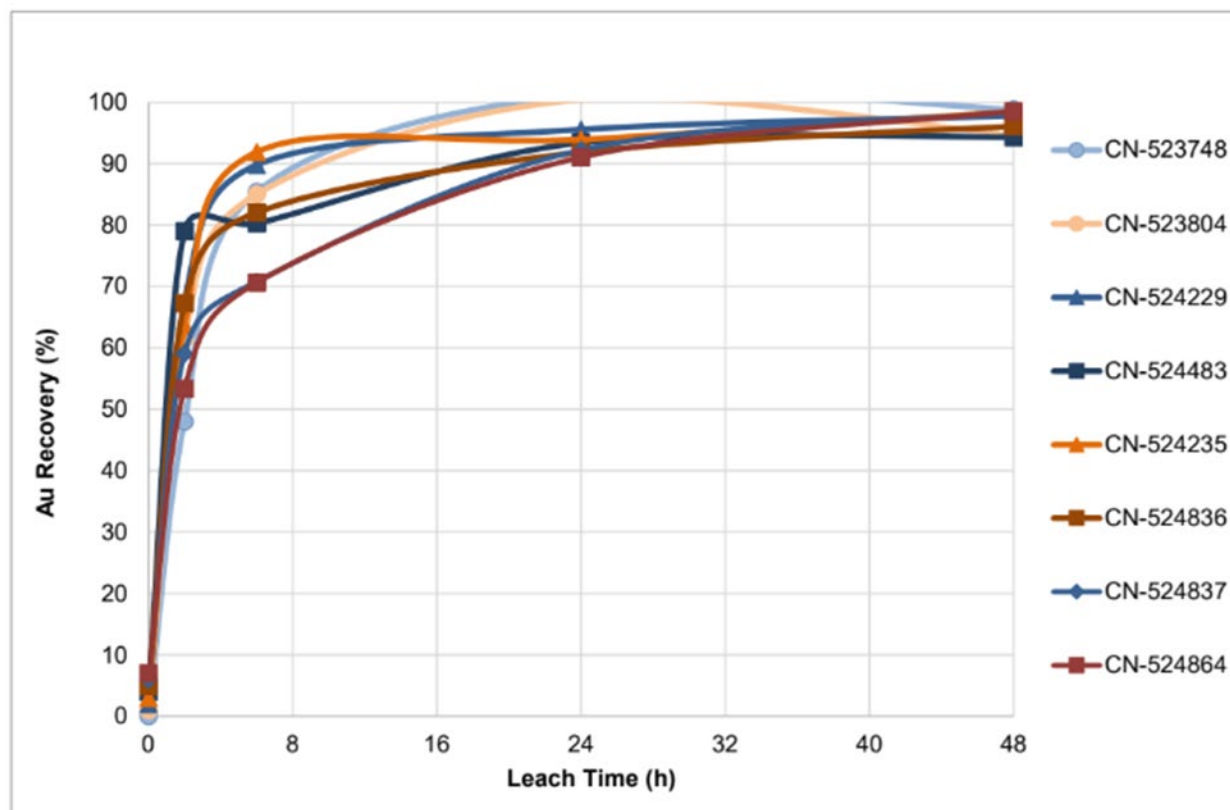
Table 3 - Bottle roll leach kinetics

Leach kinetics were rapid, with over 70% extraction achieved within the first six hours and more than 91% recovered after 24 hours, ultimately reaching maximum recoveries by 48 hours.

All tests were carried out at a grind size of approximately P80 60 μm , which contributed to the high extraction rates. The results suggest that the Gold Range samples are highly amenable to conventional mill cyanidation, with an average calculated head grade of 1.2 g/t Au and an average residual gold grade of 0.03 g/t Au in the leached tails.
